Ground Vibration Report

Summary

| Notes | PHX 3990 CYG 6435 F3<br>Duration 0.94 seconds |

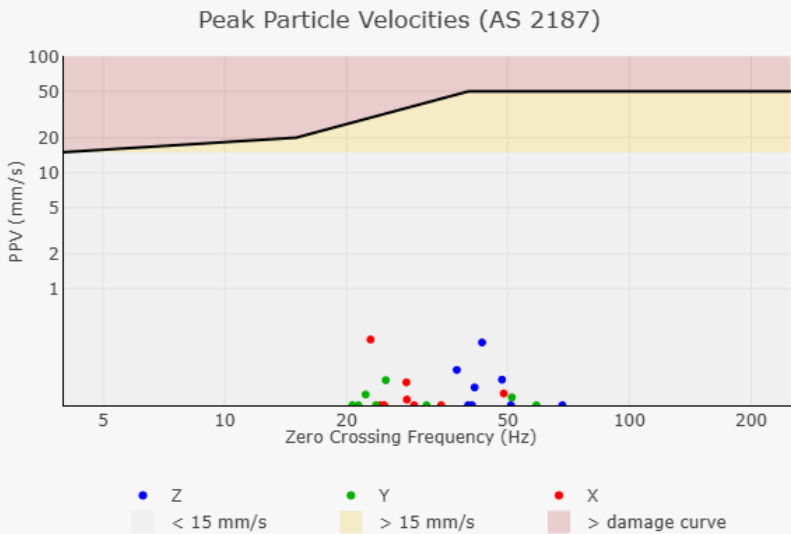
Per-component Peak Particle Velocities (PPV) vs. Zero Crossing Frequencies.  
Line indicates cosmetic damage guidelines  
(residential buildings, Fig. J4.4.2.1, AS 2187.2:2006).
