# Ground Vibration Report

| Event Date | 2026/07/30 |
| Location | Phoenix |

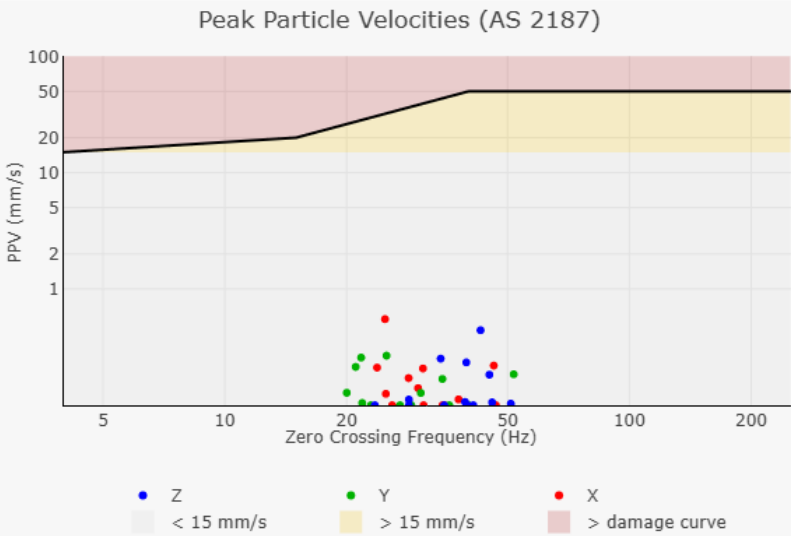
Per-component Peak Particle Velocities (PPV) vs. Zero Crossing Frequencies.  
Line indicates cosmetic damage guidelines  
(residential buildings, Fig. J4.4.2.1, AS 2187.2:2006).
