# Ground Vibration Report

| Event Type | Production Blast |
| Location | Phoenix |
| Notes | PHX 3880 CYG 6465 F2 Duration: 1.76s |

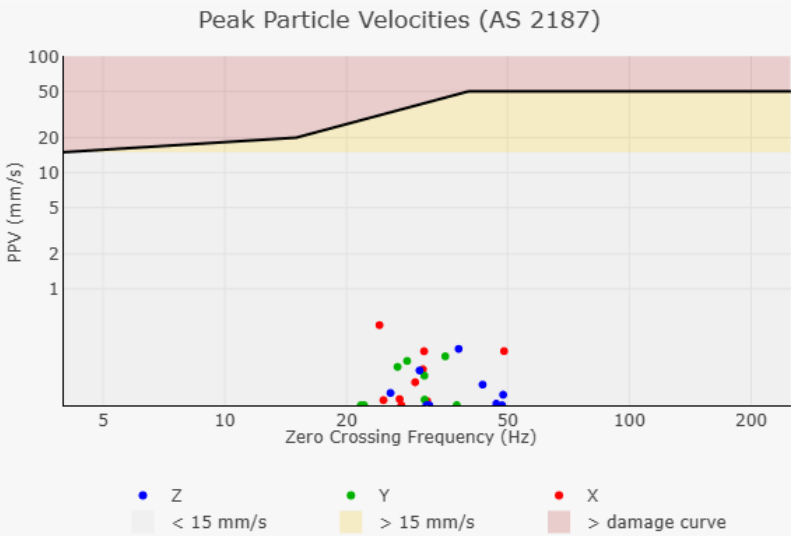
Per-component Peak Particle Velocities (PPV) vs. Zero Crossing Frequencies.  
Line indicates cosmetic damage guidelines  
(residential buildings, Fig. J4.4.2.1, AS 2187.2:2006).
