# Ground Vibration Report

| Event Type | Development Blast |
| Location | Phoenix |
| Notes | PHX 3665 DEC |

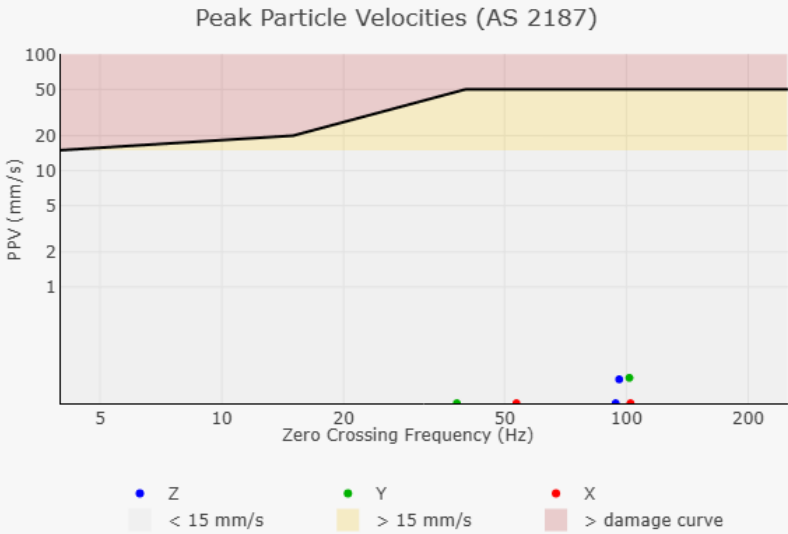
Per-component Peak Particle Velocities (PPV) vs. Zero Crossing Frequencies.  
Line indicates cosmetic damage guidelines  
(residential buildings, Fig. J4.4.2.1, AS 2187.2:2006).
