# Ground Vibration Report

| Location | Phoenix |
| Notes | PHX 3790 LPH 6035<br>Duration: 1.51s |

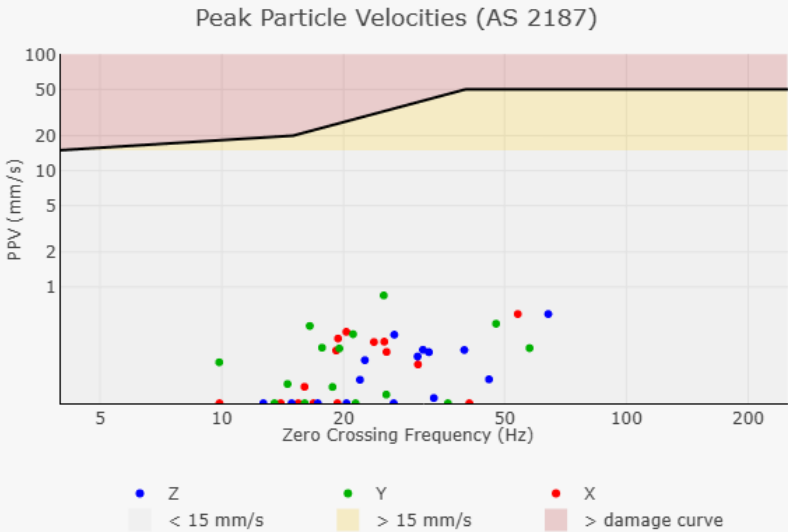
Per-component Peak Particle Velocities (PPV) vs. Zero Crossing Frequencies.  
Line indicates cosmetic damage guidelines  
(residential buildings, Fig. J4.4.2.1, AS 2187.2:2006).
