# Ground Vibration Report

| Event Date | 2026/08/24 |
| Location | Phoenix |
| Notes | PHX 3865 SWN 6080 F2<br>Duration: 0.75s |

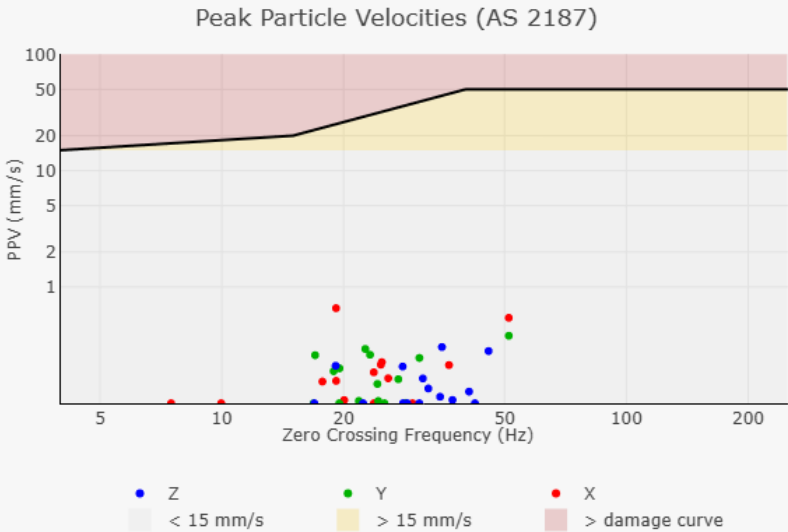
Per-component Peak Particle Velocities (PPV) vs. Zero Crossing Frequencies.  
Line indicates cosmetic damage guidelines  
(residential buildings, Fig. J4.4.2.1, AS 2187.2:2006).

Legend: Below detection threshold Below 15 mm/s Above 15 mm/s Above damage curve
