# Ground Vibration Report

| Event Date | 2026/09/04 |
| Location | Phoenix |
| Notes | PHX 3815 LPH 6080 Duration: 3.23s |

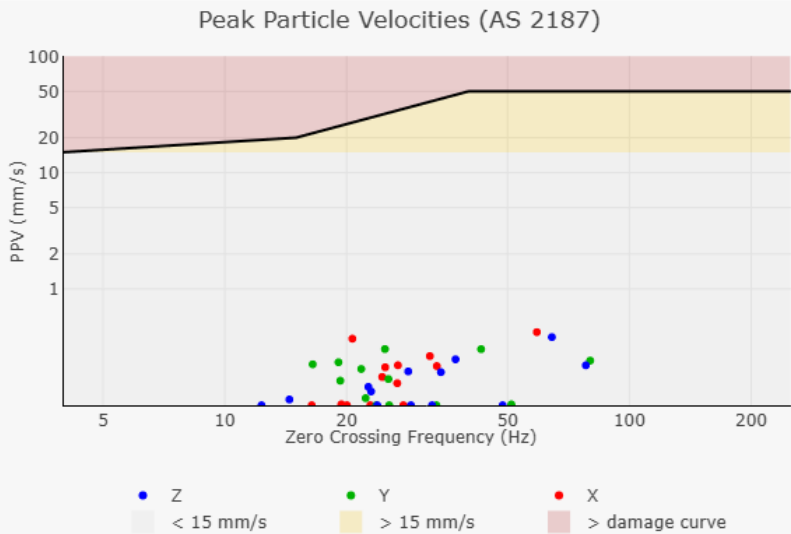
Per-component Peak Particle Velocities (PPV) vs. Zero Crossing Frequencies.  
Line indicates cosmetic damage guidelines (residential buildings, Fig. J4.4.2.1, AS 2187.2:2006).
