# Ground Vibration Report

## Summary

| Location | CRD 3750 RAW East |

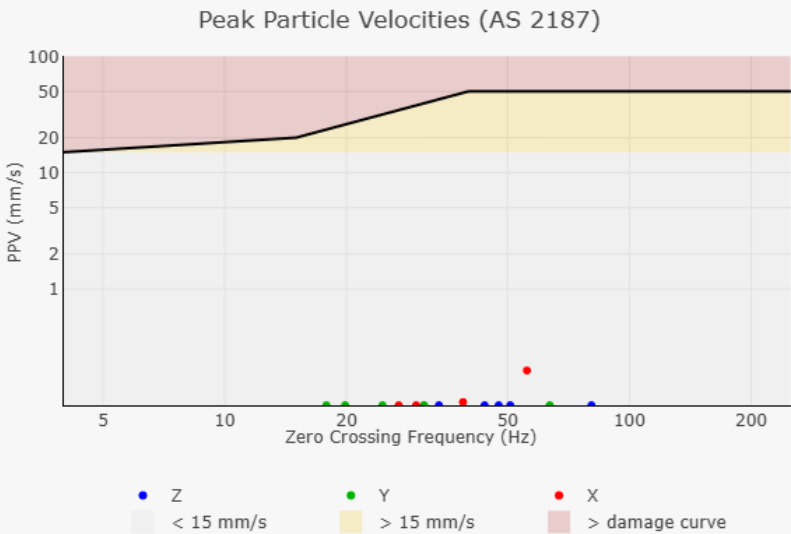
Per-component Peak Particle Velocities (PPV) vs. Zero Crossing Frequencies.  
Line indicates cosmetic damage guidelines  
(residential buildings, Fig. J4.4.2.1, AS 2187.2:2006).
