Ground Vibration Report

Summary

| Location | Phoenix 3690 DEC |

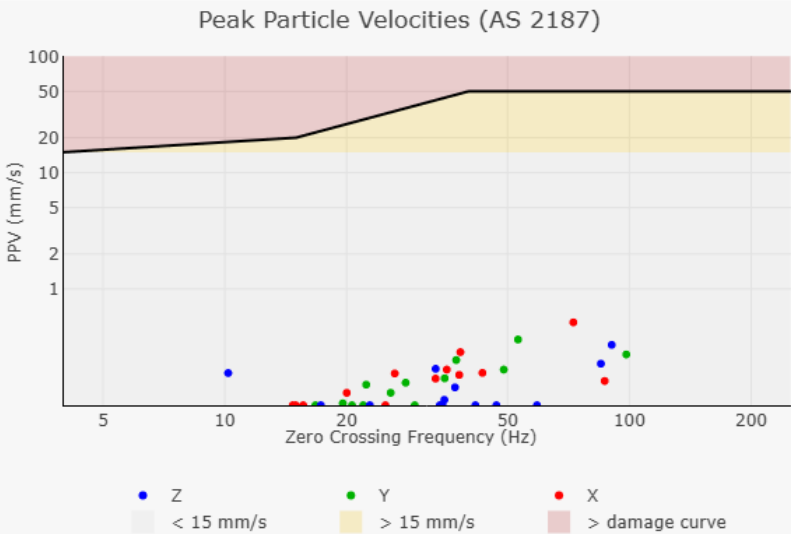
Per-component Peak Particle Velocities (PPV) vs. Zero Crossing Frequencies.  
Line indicates cosmetic damage guidelines (residential buildings, Fig. J4.4.2.1, AS 2187.2:2006).
