Ground Vibration Report

Summary

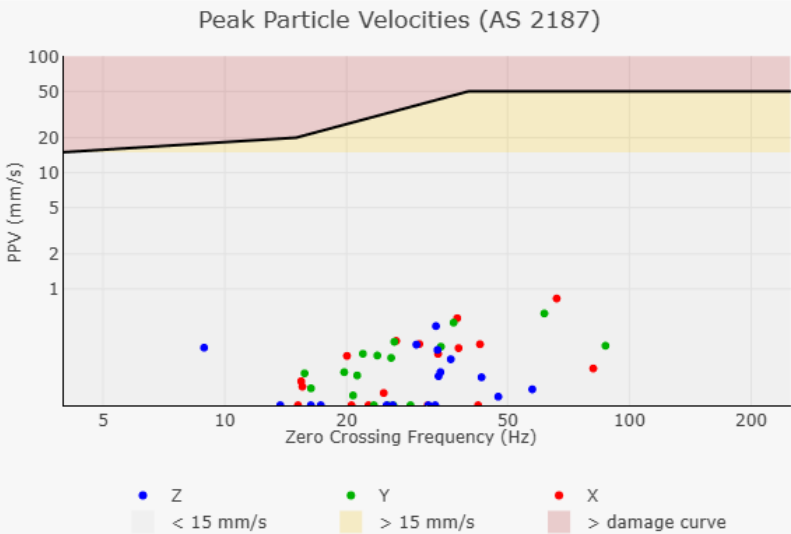
Per-component Peak Particle Velocities (PPV) vs. Zero Crossing Frequencies. Line indicates cosmetic damage guidelines (residential buildings, Fig. J4.4.2.1, AS 2187.2:2006).
