Ground Vibration Report

Summary

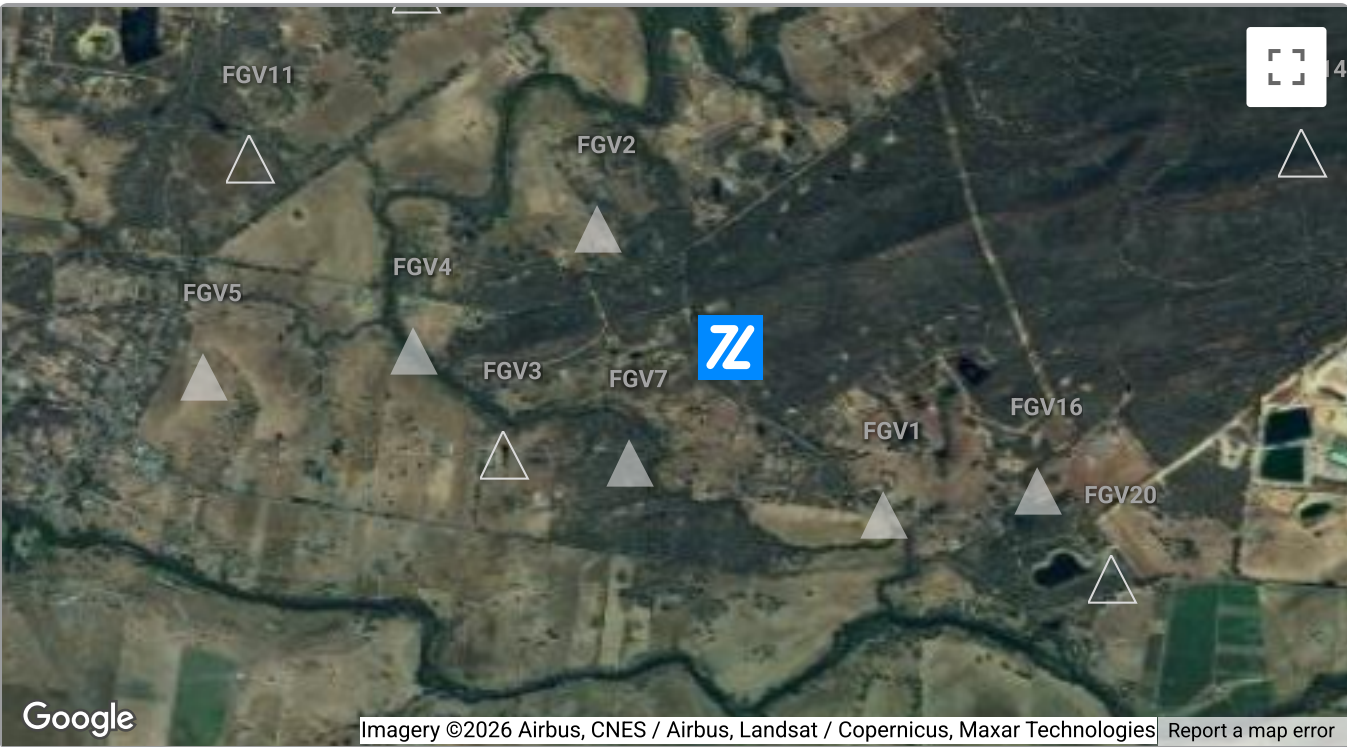
| Location | Phoenix 3740 LPH 5820 |
| Distance Below Surface | ~1390 m |

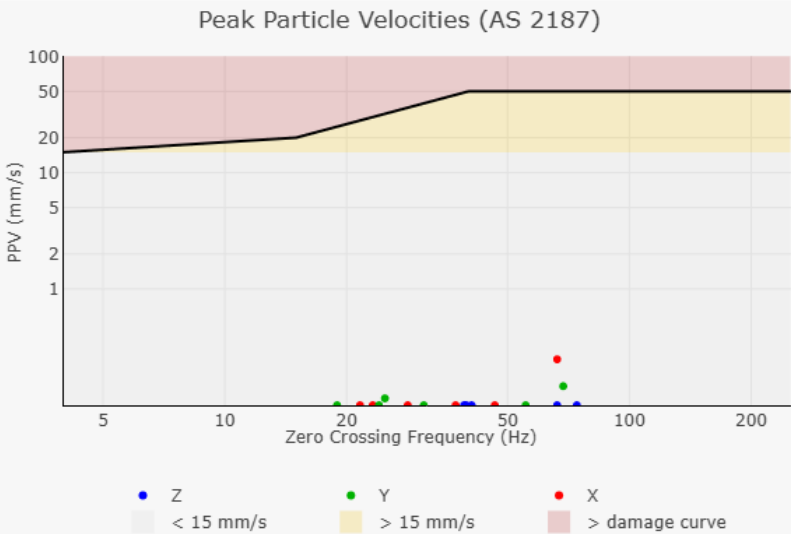
Per-component Peak Particle Velocities (PPV) vs. Zero Crossing Frequencies.  
Line indicates cosmetic damage guidelines  
(residential buildings, Fig. J4.4.2.1, AS 2187.2:2006).
