# Ground Vibration Report

| Location | Phoenix 3695 RAW |

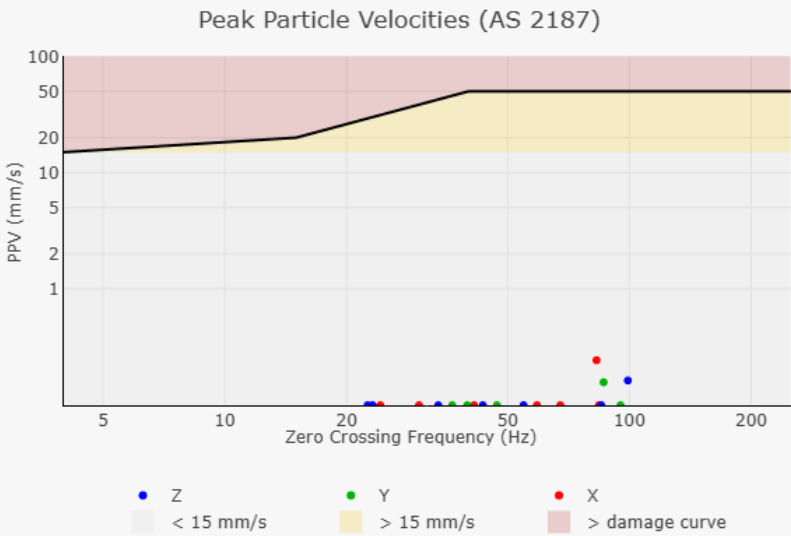
Per-component Peak Particle Velocities (PPV) vs. Zero Crossing Frequencies.  
Line indicates cosmetic damage guidelines  
(residential buildings, Fig. J4.4.2.1, AS 2187.2:2006).
