# Ground Vibration Report

| Event Type | Seismic Event |
| Magnitude | 1.4 |
| Location | Phoenix 3690 DEC |

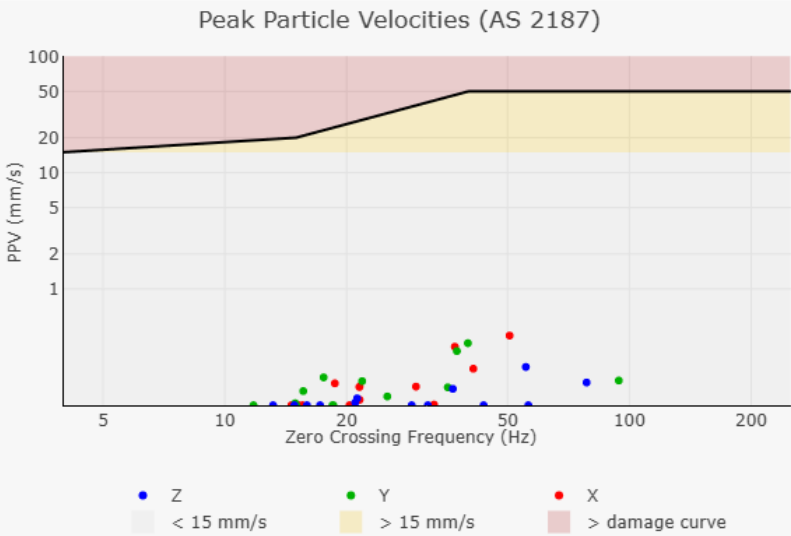
Per-component Peak Particle Velocities (PPV) vs. Zero Crossing Frequencies.  
Line indicates cosmetic damage guidelines  
(residential buildings, Fig. J4.4.2.1, AS 2187.2:2006).
