Ground Vibration Report

Summary

| Event Type | Seismic Event |
| Magnitude | 1.5 |

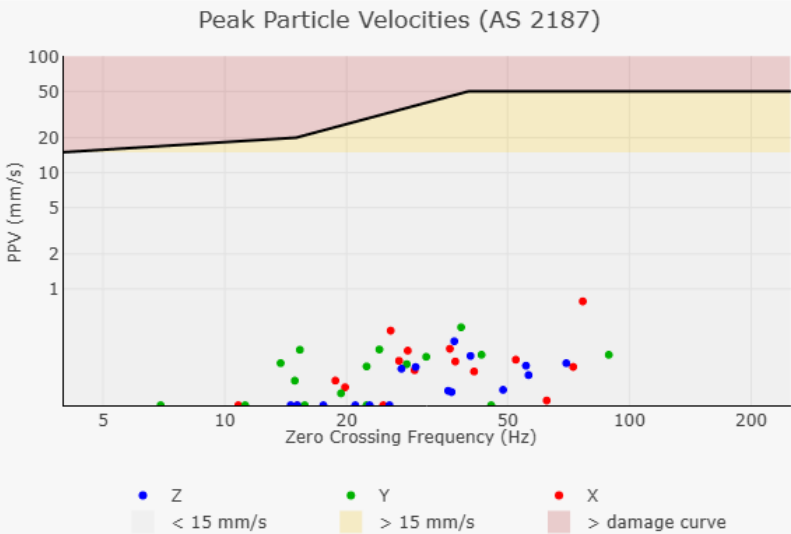
Per-component Peak Particle Velocities (PPV) vs. Zero Crossing Frequencies.  
Line indicates cosmetic damage guidelines (residential buildings, Fig. J4.4.2.1, AS 2187.2:2006).
