# Ground Vibration Report

| Event Date | 2026/02/05 |
| Location | Phoenix 3910 S ACC |

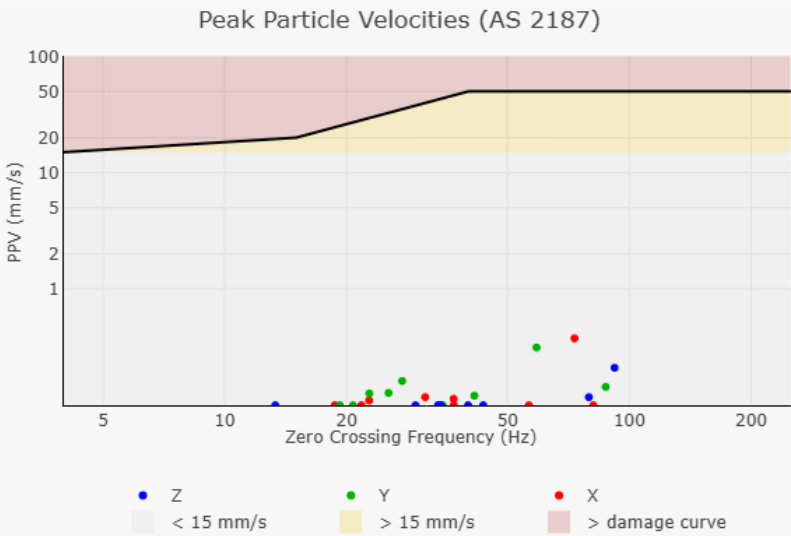
Per-component Peak Particle Velocities (PPV) vs. Zero Crossing Frequencies.  
Line indicates cosmetic damage guidelines  
(residential buildings, Fig. J4.4.2.1, AS 2187.2:2006).
