# Ground Vibration Report

## Summary

| Location | Phoenix 3695 RAW |
| Notes | Seismic event 0.7 Mw during development blast |

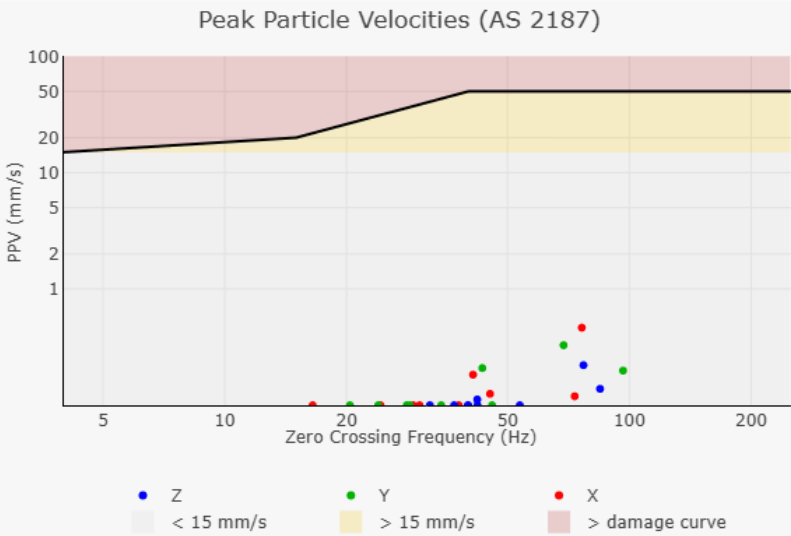
Per-component Peak Particle Velocities (PPV) vs. Zero Crossing Frequencies.  
Line indicates cosmetic damage guidelines  
(residential buildings, Fig. J4.4.2.1, AS 2187.2:2006).
