Ground Vibration Report

Summary

| Location | Phoenix 3710 DEC |

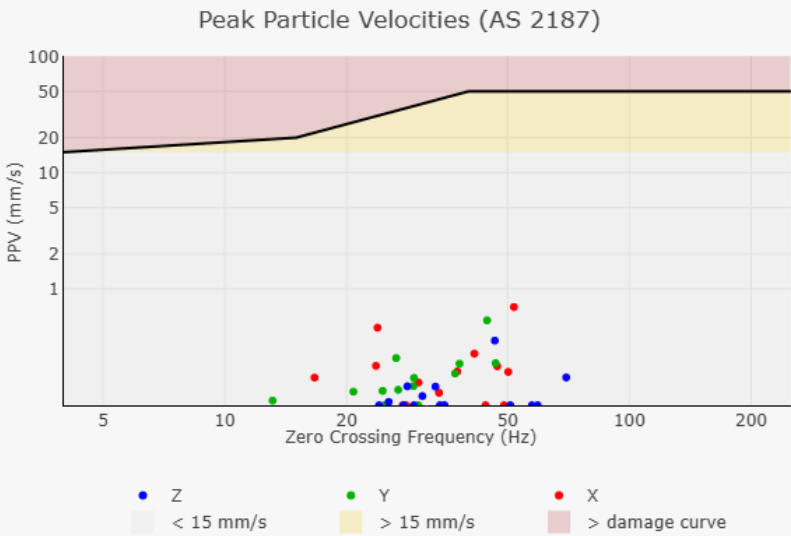
Per-component Peak Particle Velocities (PPV) vs. Zero Crossing Frequencies.  
Line indicates cosmetic damage guidelines  
(residential buildings, Fig. J4.4.2.1, AS 2187.2:2006).
