# Ground Vibration Report

## Summary

| Magnitude | 0.8 |
| Location | 325m east of Phoenix 3890 Swan |

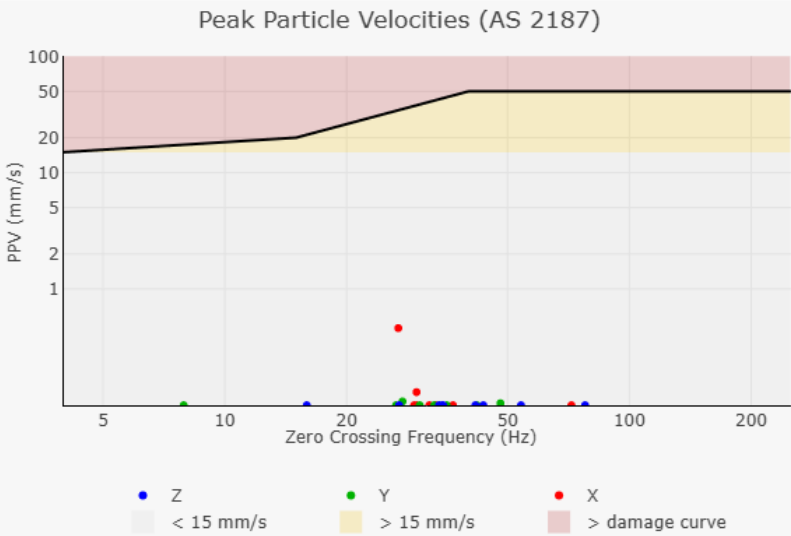
Per-component Peak Particle Velocities (PPV) vs. Zero Crossing Frequencies.  
Line indicates cosmetic damage guidelines  
(residential buildings, Fig. J4.4.2.1, AS 2187.2:2006).
