Ground Vibration Report

Summary

| Location | P3890 ACC |

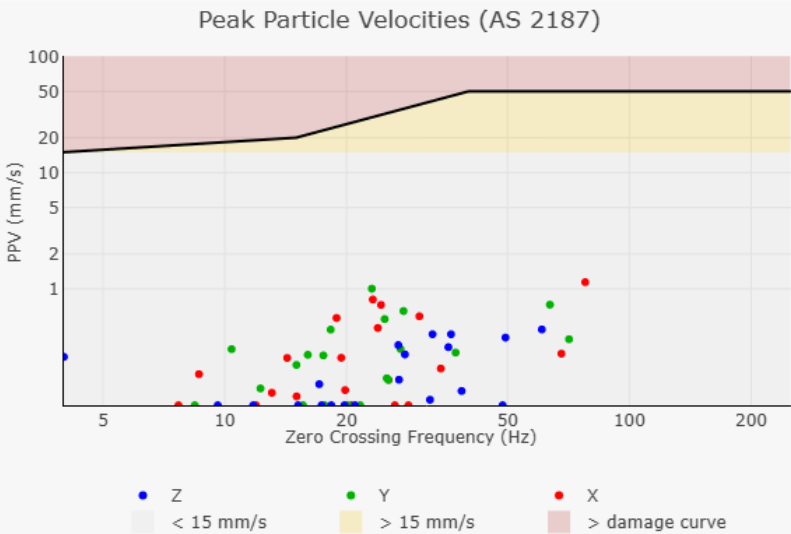
Per-component Peak Particle Velocities (PPV) vs. Zero Crossing Frequencies. Line indicates cosmetic damage guidelines (residential buildings, Fig. J4.4.2.1, AS 2187.2:2006).
