Ground Vibration Report

Summary

| Location | Phoenix 3695 RAW |

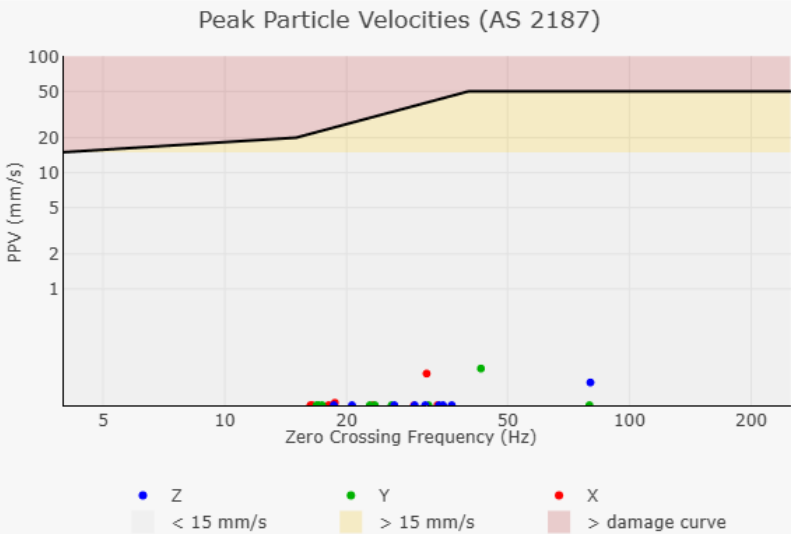
Per-component Peak Particle Velocities (PPV) vs. Zero Crossing Frequencies.  
Line indicates cosmetic damage guidelines  
(residential buildings, Fig. J4.4.2.1, AS 2187.2:2006).
