Ground Vibration Report

Summary

| Location | Phoenix 3750 CRD DEC |

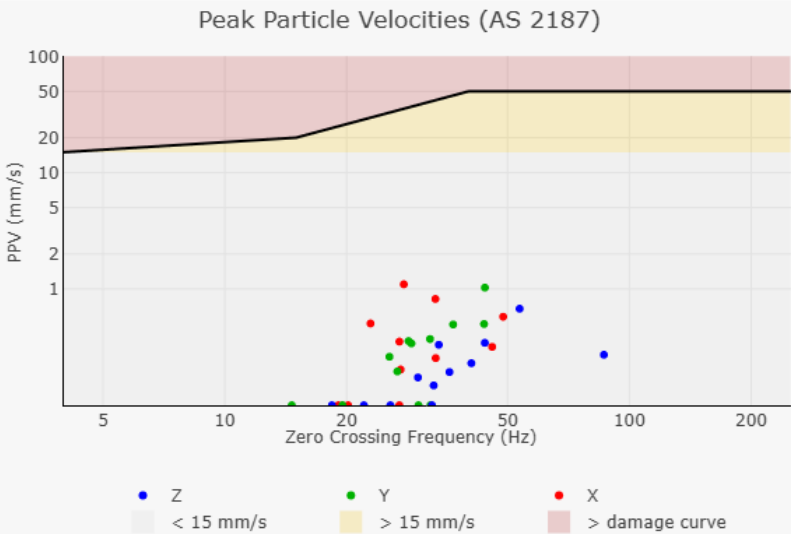
Per-component Peak Particle Velocities (PPV) vs. Zero Crossing Frequencies.  
Line indicates cosmetic damage guidelines  
(residential buildings, Fig. J4.4.2.1, AS 2187.2:2006).
