# Ground Vibration Report

## Summary

| Magnitude | 1.3 |
| Location | Phoenix 3790 LPH 6010 |

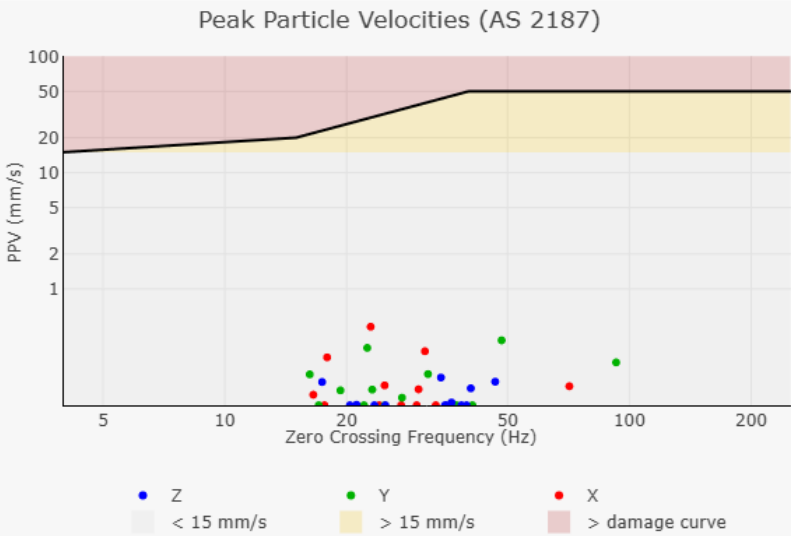
Per-component Peak Particle Velocities (PPV) vs. Zero Crossing Frequencies.  
Line indicates cosmetic damage guidelines  
(residential buildings, Fig. J4.4.2.1, AS 2187.2:2006).
