Ground Vibration Report

| Location | Phoenix 3890 Swan B |

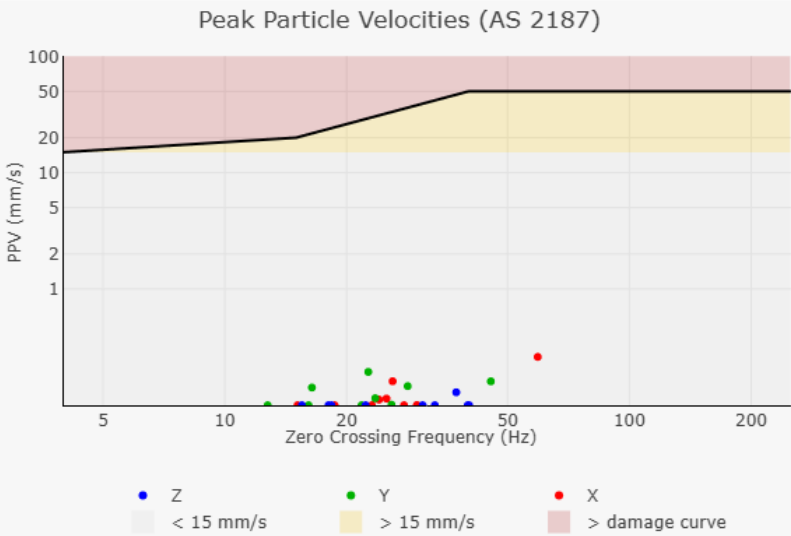
Per-component Peak Particle Velocities (PPV) vs. Zero Crossing Frequencies.  
Line indicates cosmetic damage guidelines  
(residential buildings, Fig. J4.4.2.1, AS 2187.2:2006).
