# Ground Vibration Report

| Event Date | 2026/03/19 |
| Location | Phoenix 3670 CRD DEC |

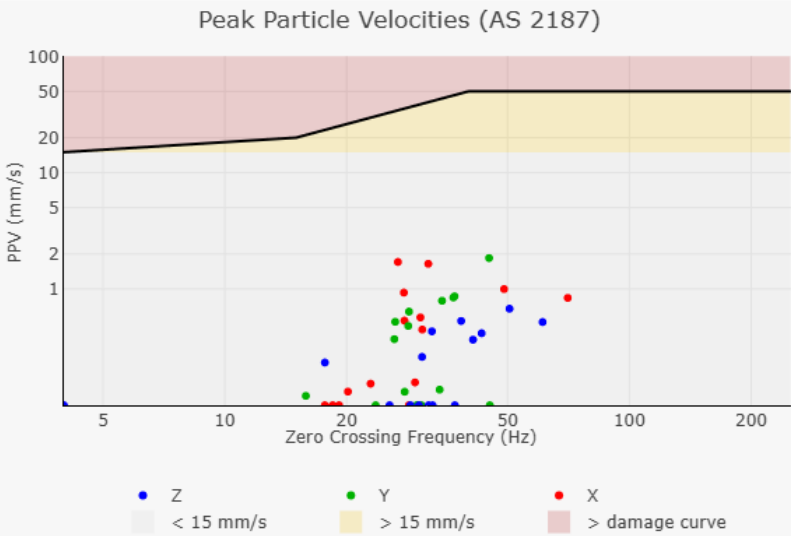
Per-component Peak Particle Velocities (PPV) vs. Zero Crossing Frequencies.  
Line indicates cosmetic damage guidelines  
(residential buildings, Fig. J4.4.2.1, AS 2187.2:2006).
