# Ground Vibration Report

## Summary

| Location | Phoenix 3695 RAW |

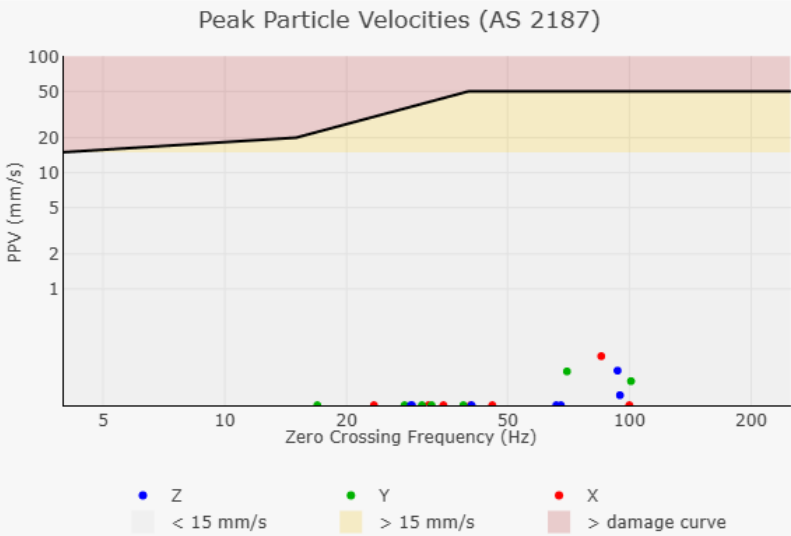
Per-component Peak Particle Velocities (PPV) vs. Zero Crossing Frequencies.  
Line indicates cosmetic damage guidelines  
(residential buildings, Fig. J4.4.2.1, AS 2187.2:2006).
