Ground Vibration Report

| Location | Phoenix 3740 LPH |

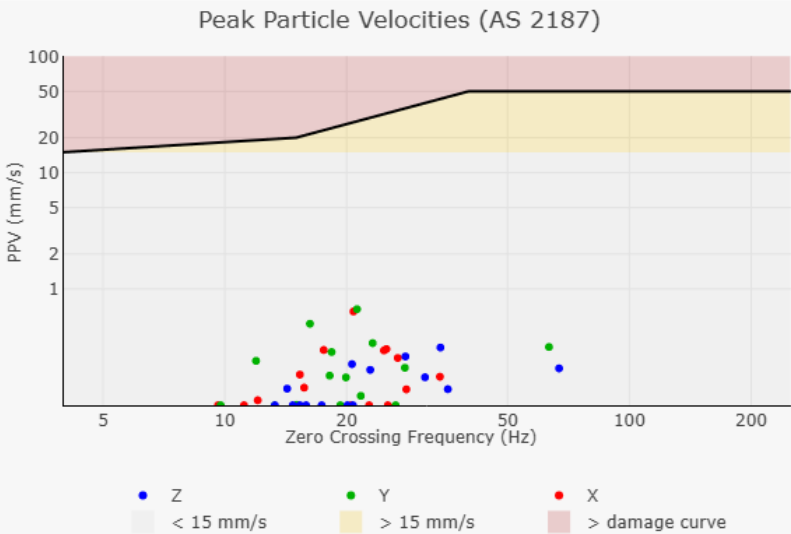
Per-component Peak Particle Velocities (PPV) vs. Zero Crossing Frequencies. Line indicates cosmetic damage guidelines (residential buildings, Fig. J4.4.2.1, AS 2187.2:2006).
