Ground Vibration Report

Summary

| Location | Phoenix 3765 LPH 5934 |

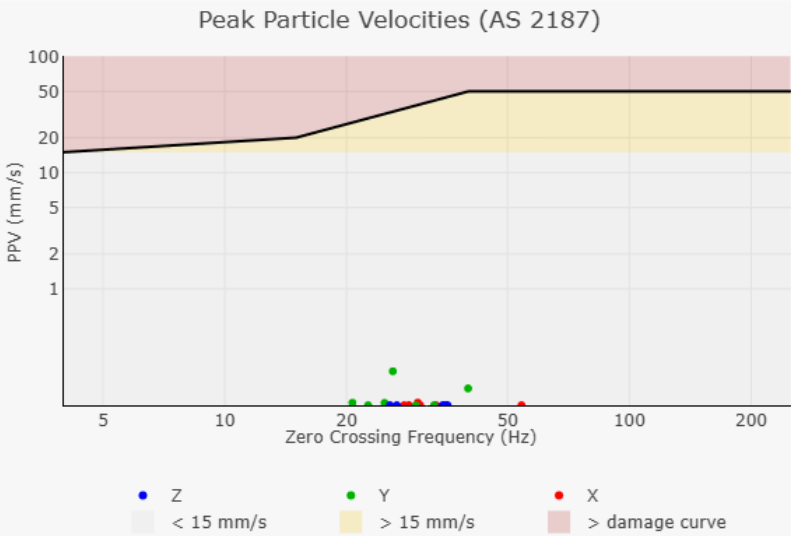
Per-component Peak Particle Velocities (PPV) vs. Zero Crossing Frequencies.  
Line indicates cosmetic damage guidelines  
(residential buildings, Fig. J4.4.2.1, AS 2187.2:2006).
