Ground Vibration Report

Summary

| Location | Phoenix 3890 SACC |

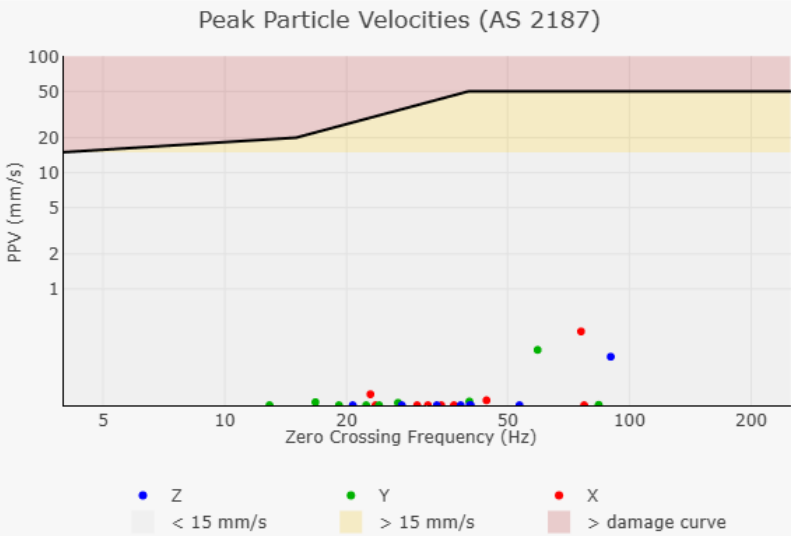
Per-component Peak Particle Velocities (PPV) vs. Zero Crossing Frequencies.  
Line indicates cosmetic damage guidelines  
(residential buildings, Fig. J4.4.2.1, AS 2187.2:2006).
