Ground Vibration Report

| Location | Phoenix 3765 LPH |

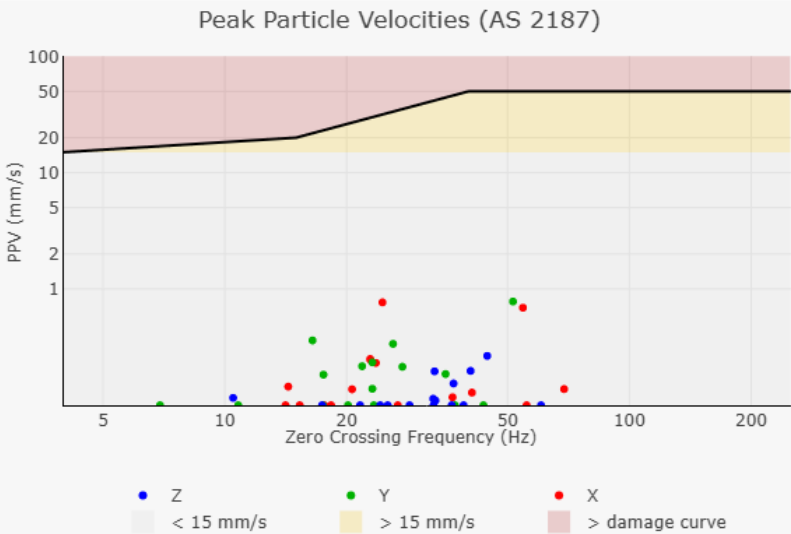
Per-component Peak Particle Velocities (PPV) vs. Zero Crossing Frequencies.  
Line indicates cosmetic damage guidelines  
(residential buildings, Fig. J4.4.2.1, AS 2187.2:2006).
