Ground Vibration Report

| Location | Phoenix 3690 ACC |

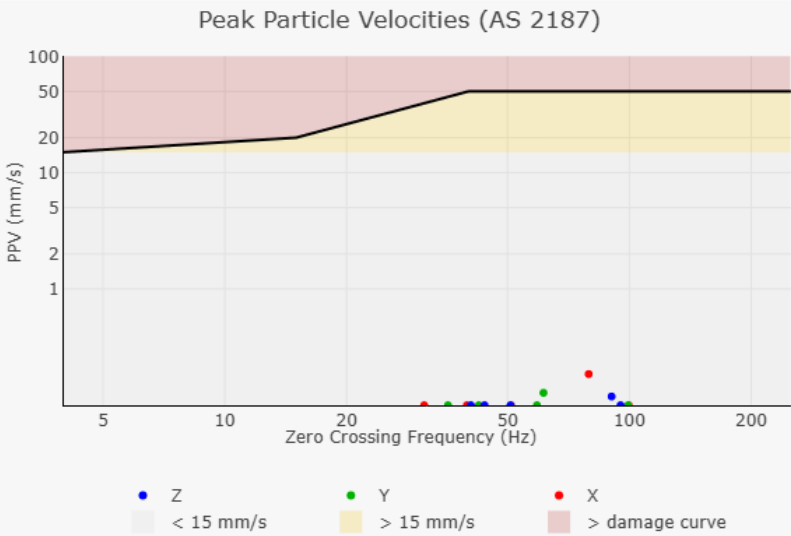
Per-component Peak Particle Velocities (PPV) vs. Zero Crossing Frequencies.  
Line indicates cosmetic damage guidelines  
(residential buildings, Fig. J4.4.2.1, AS 2187.2:2006).
