# Ground Vibration Report

| Event Type | Seismic Event |
| Magnitude | 1.1 |
| Location | Phoenix 3690 ACC |

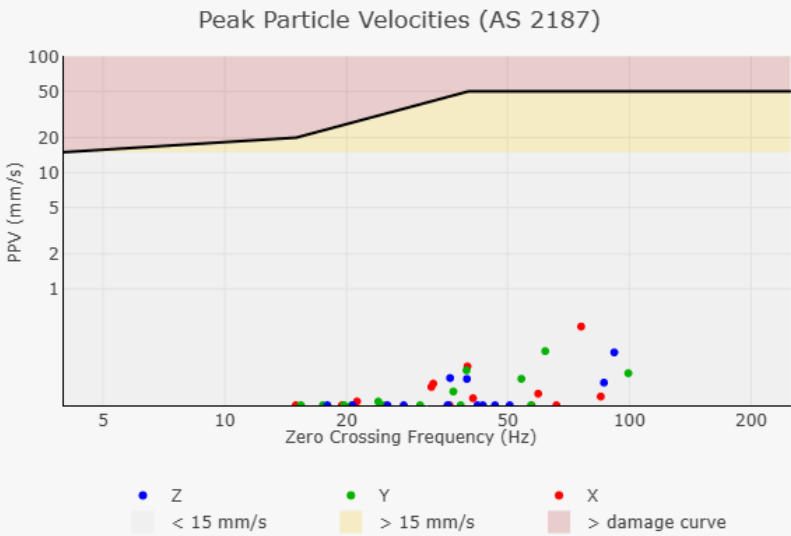
Per-component Peak Particle Velocities (PPV) vs. Zero Crossing Frequencies.  
Line indicates cosmetic damage guidelines  
(residential buildings, Fig. J4.4.2.1, AS 2187.2:2006).
