# Ground Vibration Report

| Event Type | Seismic Event |
| Magnitude | 1.3 |
| Location | Phoenix 3690 ACC |

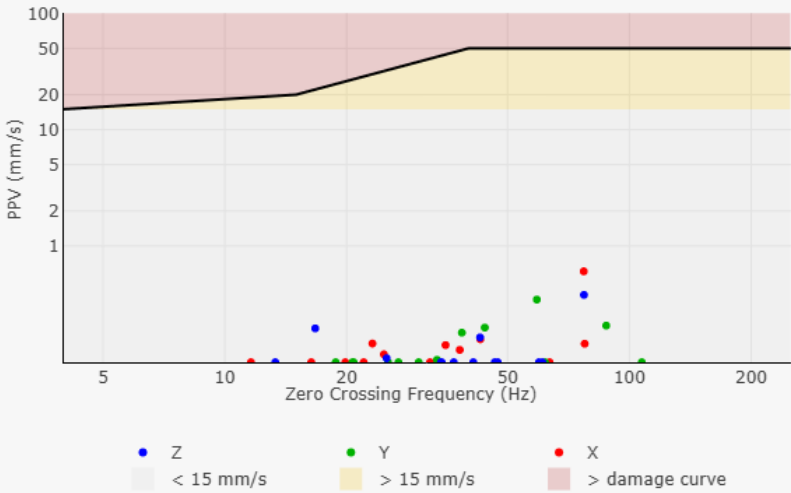
Peak Particle Velocities (AS 2187)

Per-component Peak Particle Velocities (PPV) vs. Zero Crossing Frequencies.  
Line indicates cosmetic damage guidelines  
(residential buildings, Fig. J4.4.2.1, AS 2187.2:2006).
