Ground Vibration Report

Summary

| Location | Phoenix 3665 Decline |

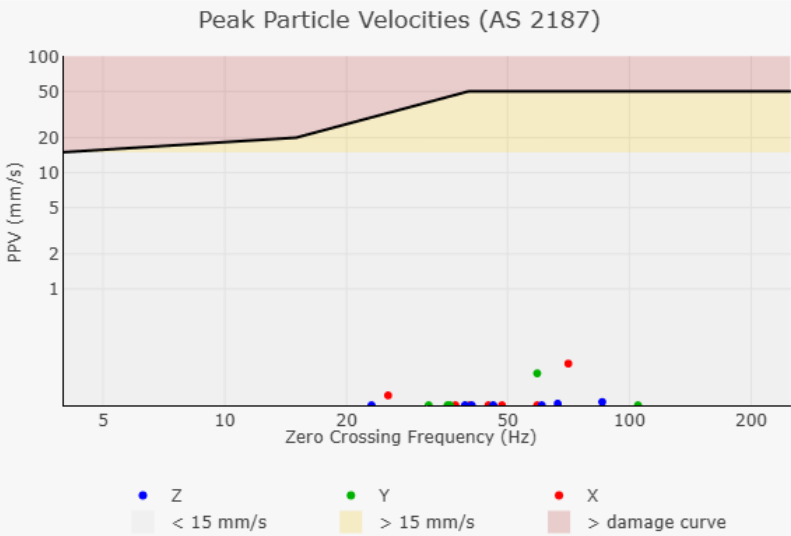
Per-component Peak Particle Velocities (PPV) vs. Zero Crossing Frequencies.  
Line indicates cosmetic damage guidelines  
(residential buildings, Fig. J4.4.2.1, AS 2187.2:2006).
