Ground Vibration Report

Summary

| Location | Phoenix 3890 SACC |

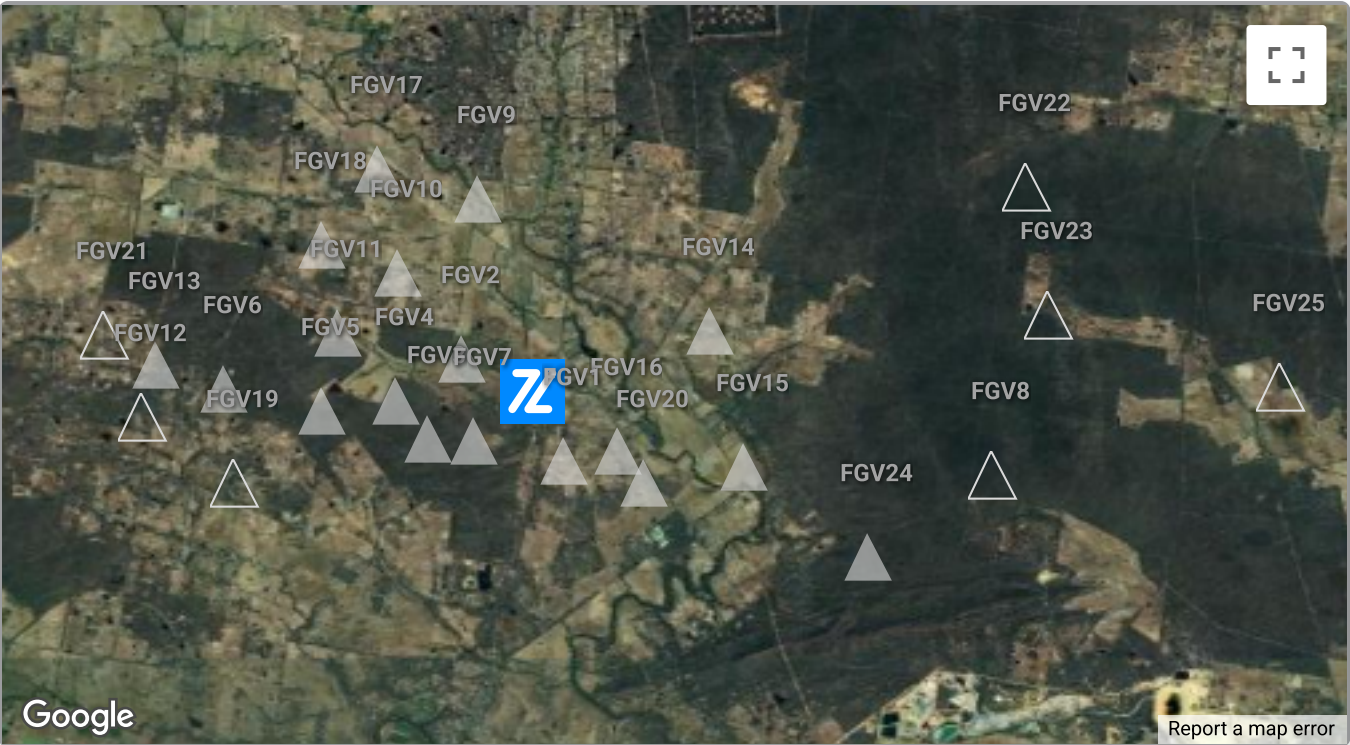
| Distance Below Surface | ~1320 m |

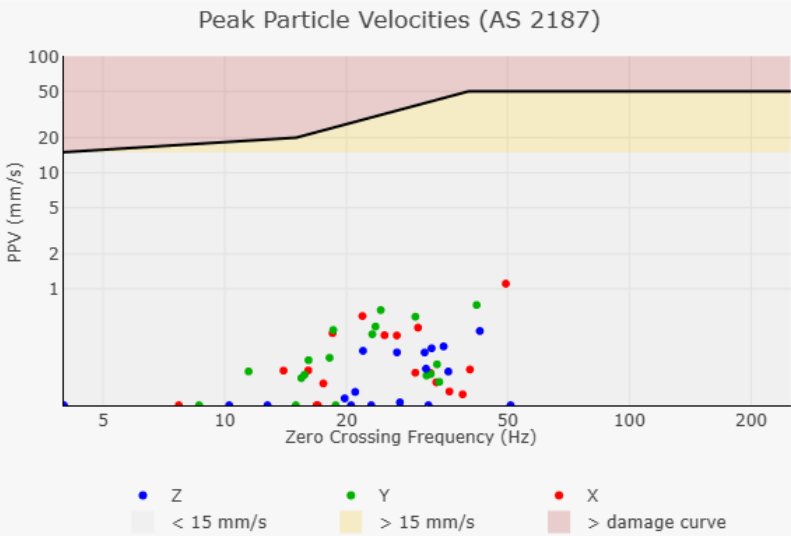
Per-component Peak Particle Velocities (PPV) vs. Zero Crossing Frequencies. Line indicates cosmetic damage guidelines (residential buildings, Fig. J4.4.2.1, AS 2187.2:2006).
