Ground Vibration Report

Summary

| Location | Phoenix 3690 DEC |

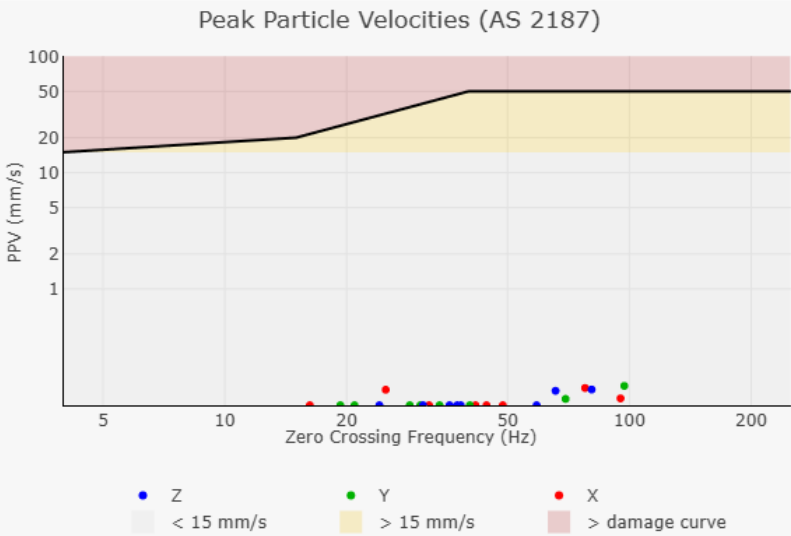
Per-component Peak Particle Velocities (PPV) vs. Zero Crossing Frequencies.  
Line indicates cosmetic damage guidelines  
(residential buildings, Fig. J4.4.2.1, AS 2187.2:2006).
