Ground Vibration Report

Summary

| Location | 1km east of Harrier 4770 Raw |

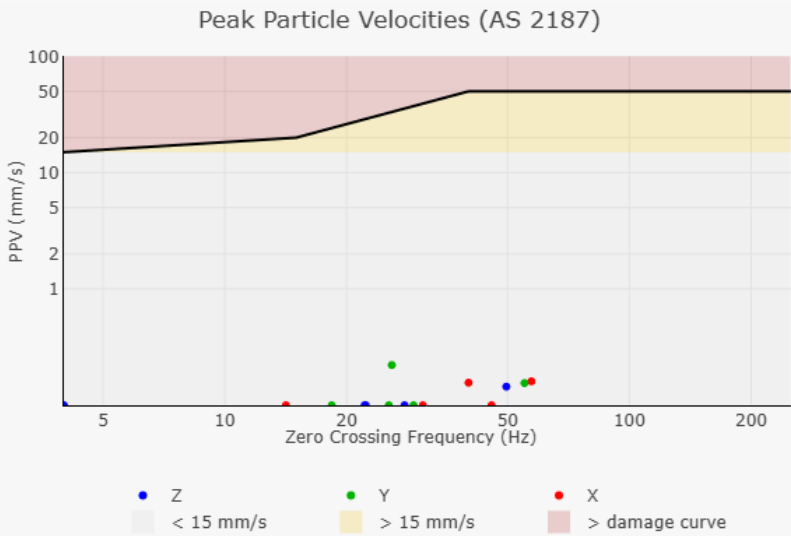
Per-component Peak Particle Velocities (PPV) vs. Zero Crossing Frequencies.  
Line indicates cosmetic damage guidelines  
(residential buildings, Fig. J4.4.2.1, AS 2187.2:2006).
