Ground Vibration Report

Summary

| Location | Phoenix 3690 ACC |

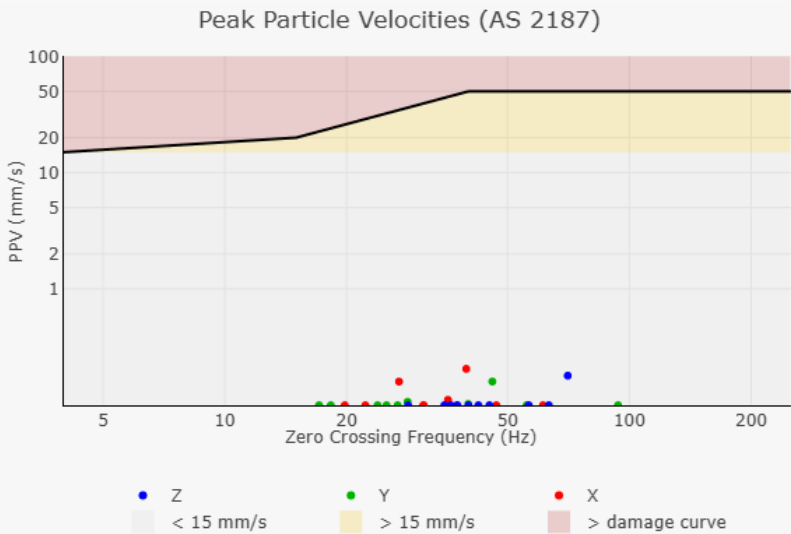
Per-component Peak Particle Velocities (PPV) vs. Zero Crossing Frequencies.  
Line indicates cosmetic damage guidelines  
(residential buildings, Fig. J4.4.2.1, AS 2187.2:2006).
