# Ground Vibration Report

## Summary

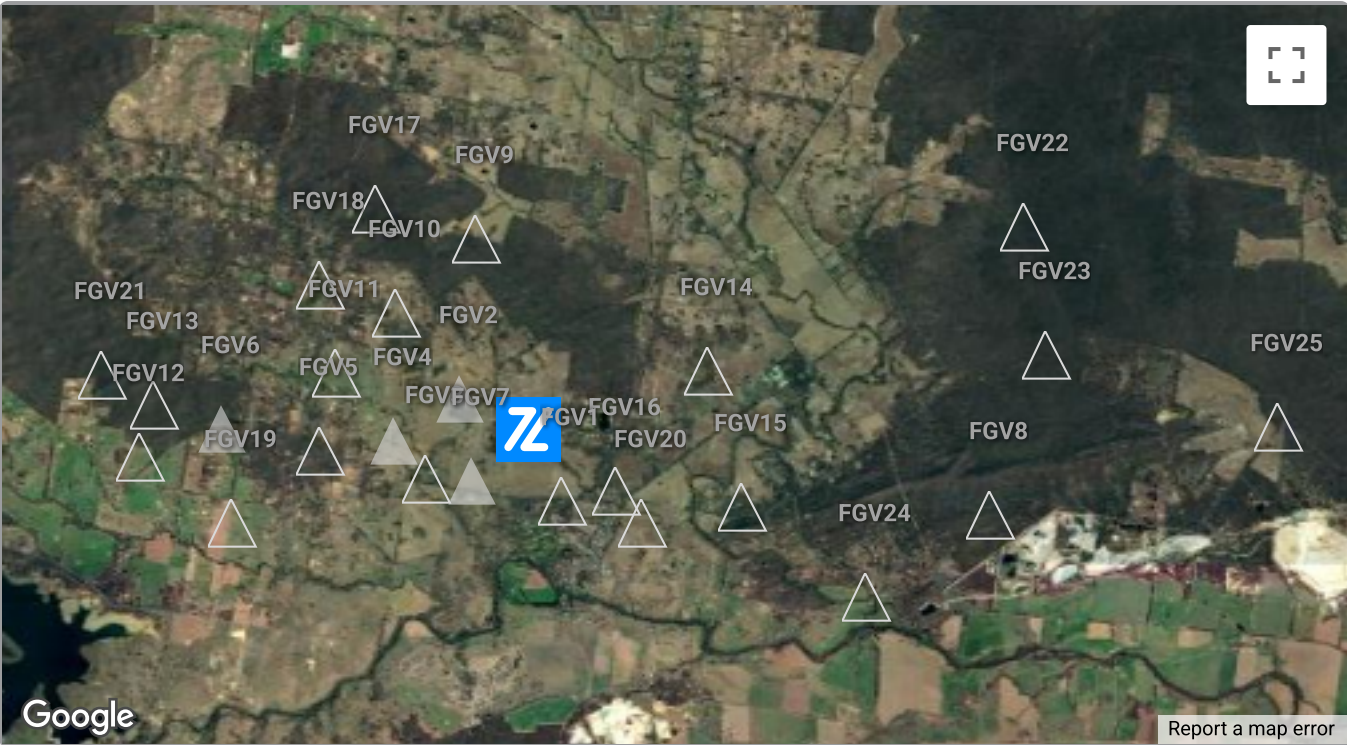
| Event Type | Seismic Event |
| Magnitude | 0.7 |
| Location | Phoenix 3690 ACC |
| Distance Below Surface | ~1470 m |

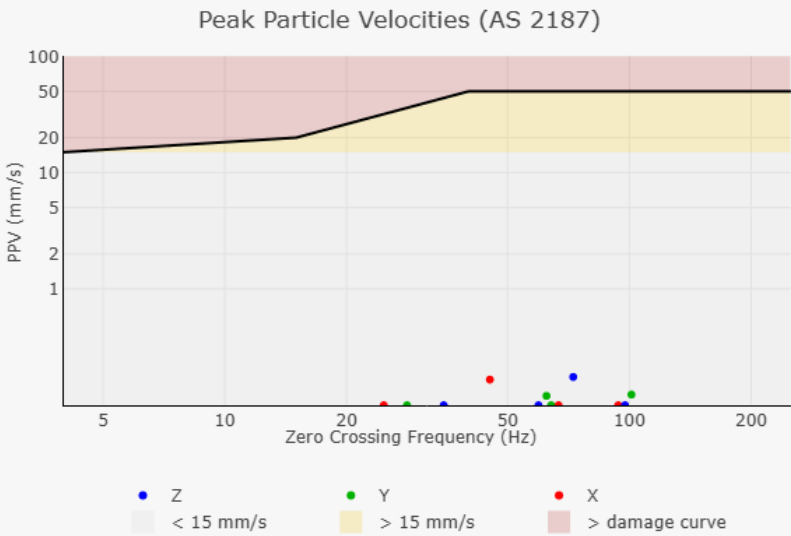
Per-component Peak Particle Velocities (PPV) vs. Zero Crossing Frequencies.  
Line indicates cosmetic damage guidelines  
(residential buildings, Fig. J4.4.2.1, AS 2187.2:2006).
