# Ground Vibration Report

| Event Date | 2026/07/07 |
| Location | Phoenix 3690 ACC |

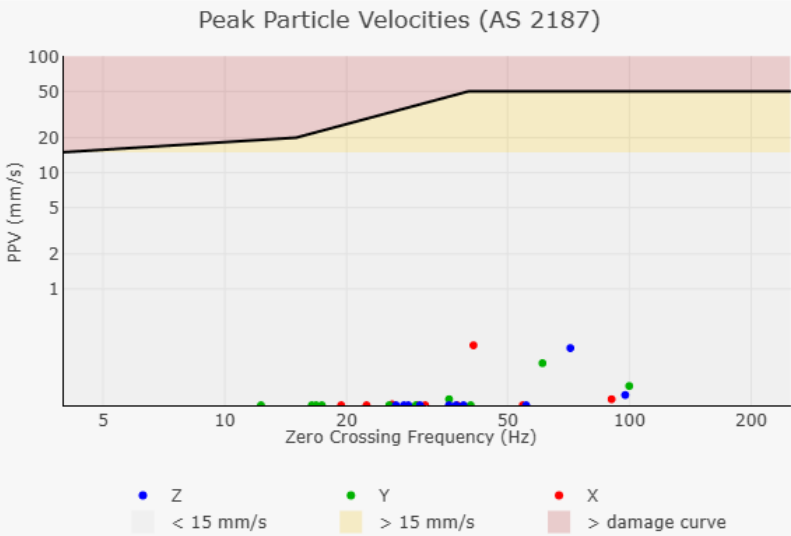
Per-component Peak Particle Velocities (PPV) vs. Zero Crossing Frequencies.  
Line indicates cosmetic damage guidelines  
(residential buildings, Fig. J4.4.2.1, AS 2187.2:2006).
