Ground Vibration Report

Summary

| Location | Phoenix 3690 ACC |

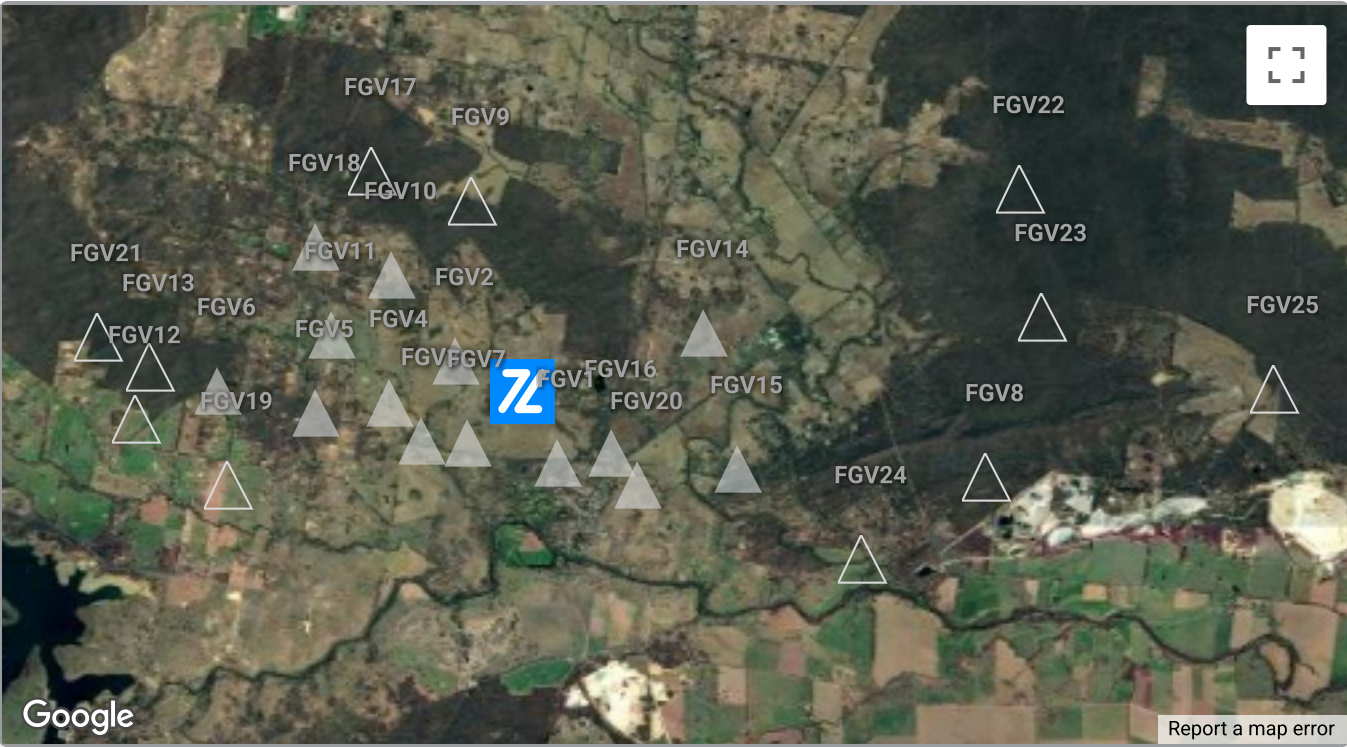
| Distance Below Surface | ~1470 m |

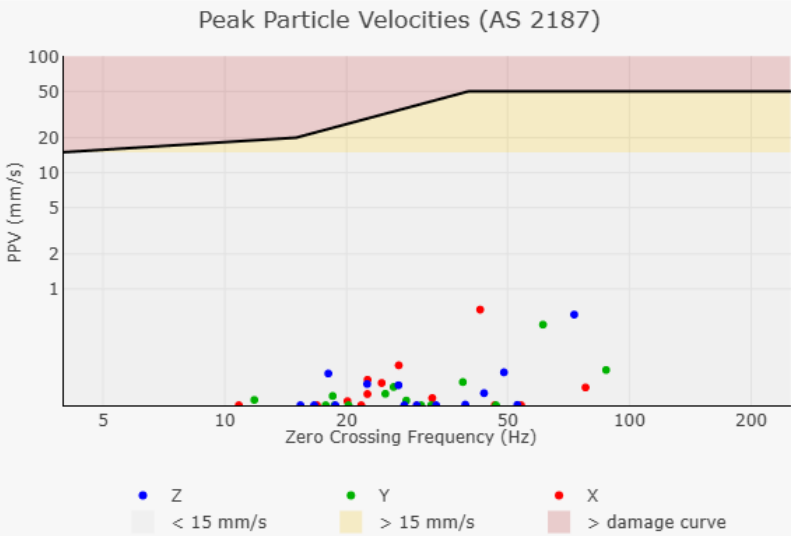
Per-component Peak Particle Velocities (PPV) vs. Zero Crossing Frequencies.  
Line indicates cosmetic damage guidelines  
(residential buildings, Fig. J4.4.2.1, AS 2187.2:2006).
