Ground Vibration Report

Summary

| Location | Phoenix 3690 PF E |

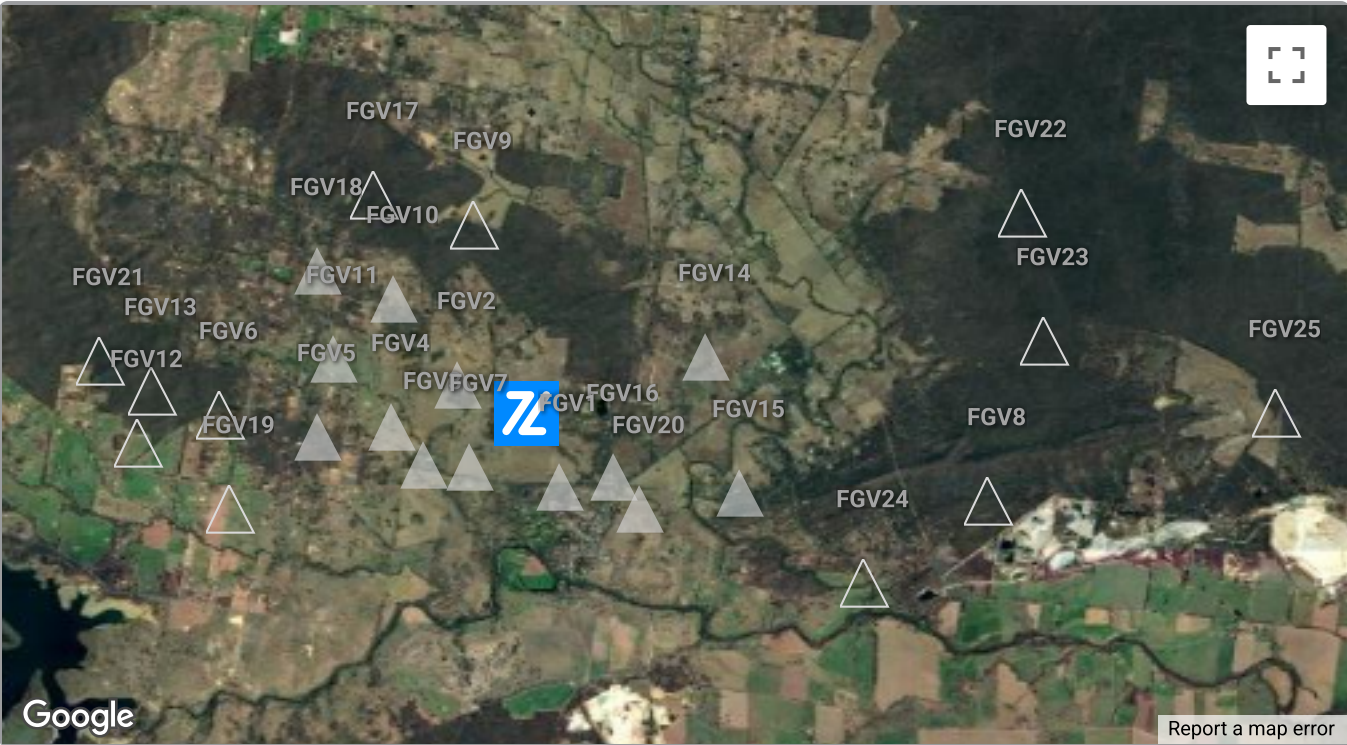
| Distance Below Surface | ~1470 m |

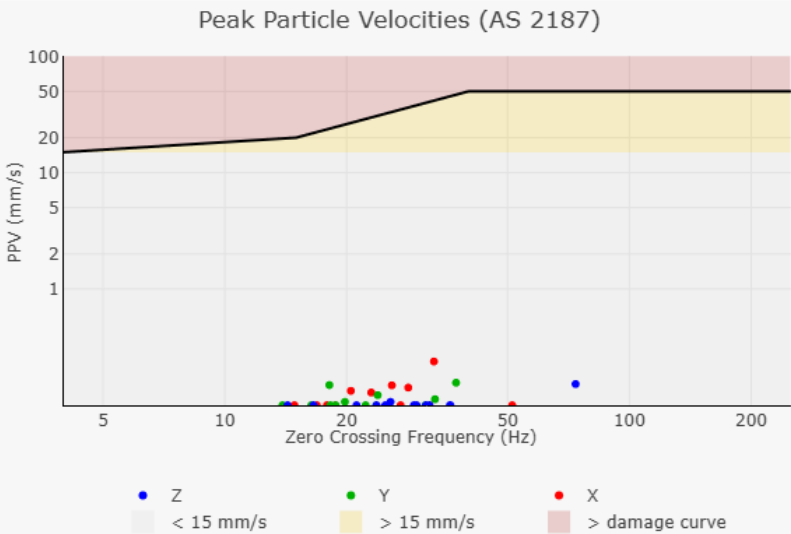
Per-component Peak Particle Velocities (PPV) vs. Zero Crossing Frequencies.  
Line indicates cosmetic damage guidelines  
(residential buildings, Fig. J4.4.2.1, AS 2187.2:2006).
