Ground Vibration Report

Summary

| Location | Phoenix 4105 Raptor Acc |

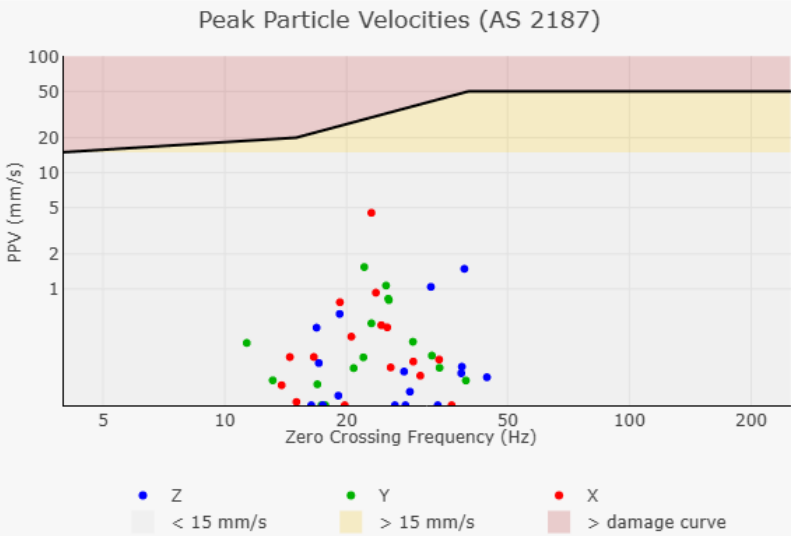
Per-component Peak Particle Velocities (PPV) vs. Zero Crossing Frequencies. Line indicates cosmetic damage guidelines (residential buildings, Fig. J4.4.2.1, AS 2187.2:2006).
