Ground Vibration Report

Summary

| Notes | Approx 21m west of PHX 3890 S ACC |

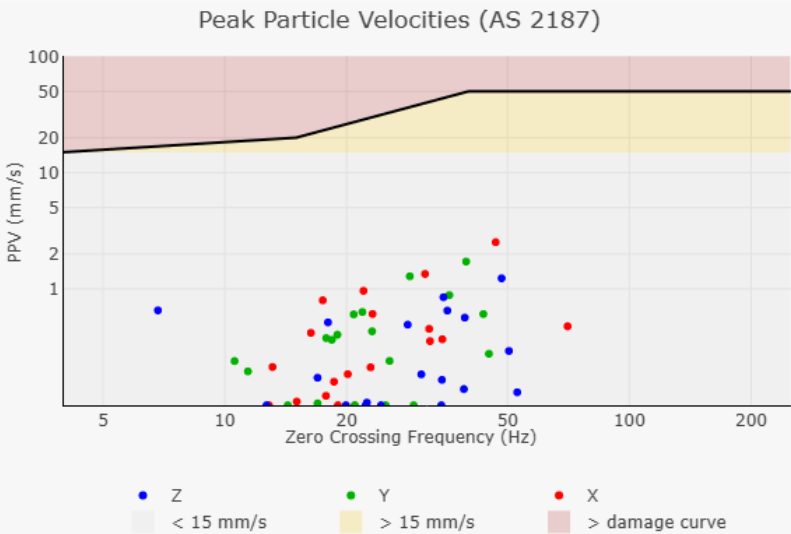
Per-component Peak Particle Velocities (PPV) vs. Zero Crossing Frequencies. Line indicates cosmetic damage guidelines (residential buildings, Fig. J4.4.2.1, AS 2187.2:2006).
