# Ground Vibration Report

| Event Type | Seismic Event |
| Location | Phoenix |

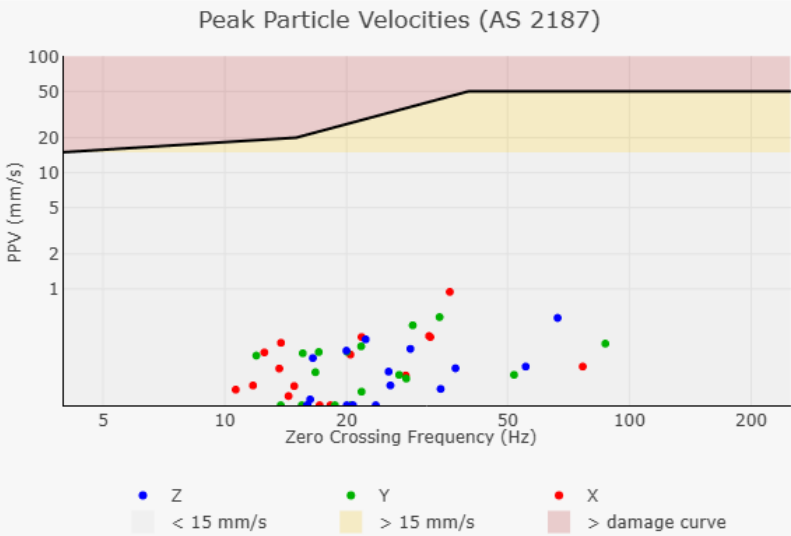
Per-component Peak Particle Velocities (PPV) vs. Zero Crossing Frequencies.  
Line indicates cosmetic damage guidelines  
(residential buildings, Fig. J4.4.2.1, AS 2187.2:2006).

Legend: Below detection threshold Below 15 mm/s Above 15 mm/s Above damage curve
