PARLIAMENT HOUSE COURTYARD WATERPROOFING

REMEDIAL WATERPROOFING & TILING

Parliament House Courtyard Waterproofing

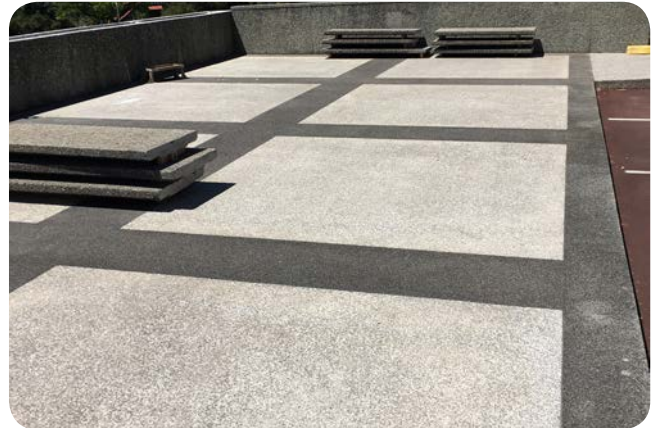
- Courtyard prior to remediation.
- Installation of waterproofing membrane.
- Completed works.
