# Ground Vibration Report

| Event Date | 2026/01/05 |
| Location | Phoenix 3865 SWN 6090 |

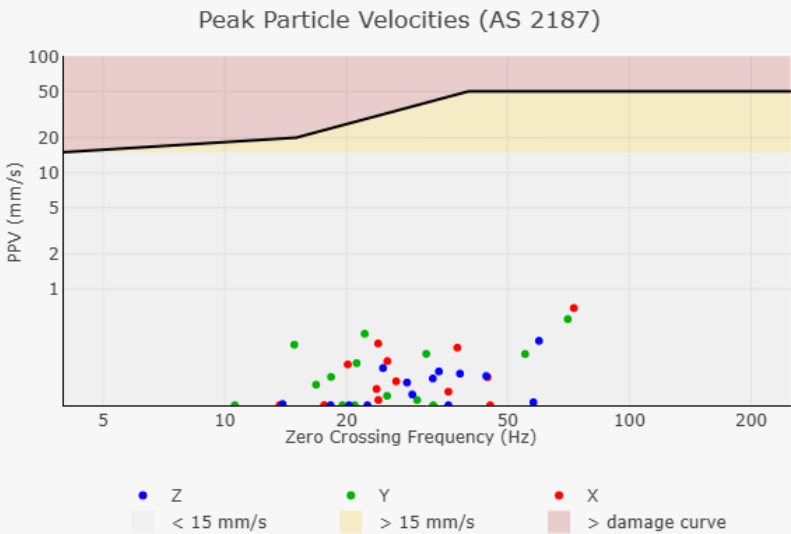
Per-component Peak Particle Velocities (PPV) vs. Zero Crossing Frequencies.  
Line indicates cosmetic damage guidelines  
(residential buildings, Fig. J4.4.2.1, AS 2187.2:2006).
