# Ground Vibration Report

## Summary

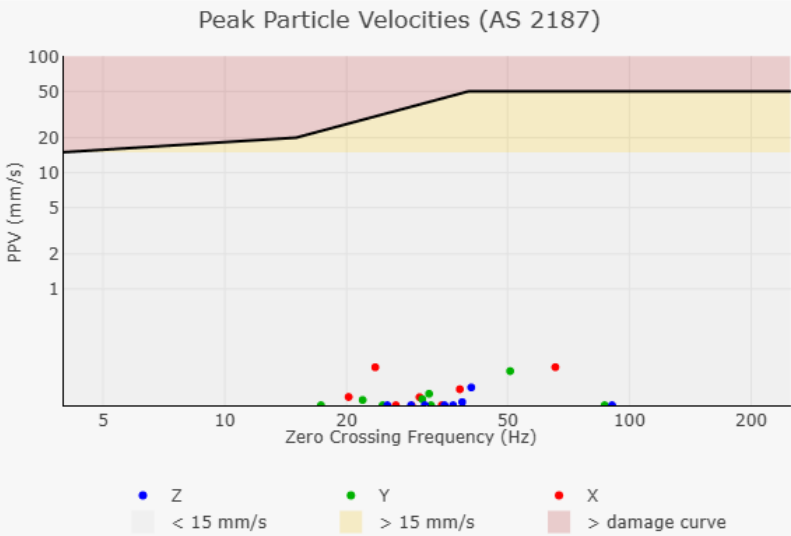
Per-component Peak Particle Velocities (PPV) vs. Zero Crossing Frequencies.  
Line indicates cosmetic damage guidelines  
(residential buildings, Fig. J4.4.2.1, AS 2187.2:2006).
