Ground Vibration Report

| Event Time | 18:31:15 Australia/Melbourne |
| Location | Harrier 4240 - Harrier 4260 RAR |

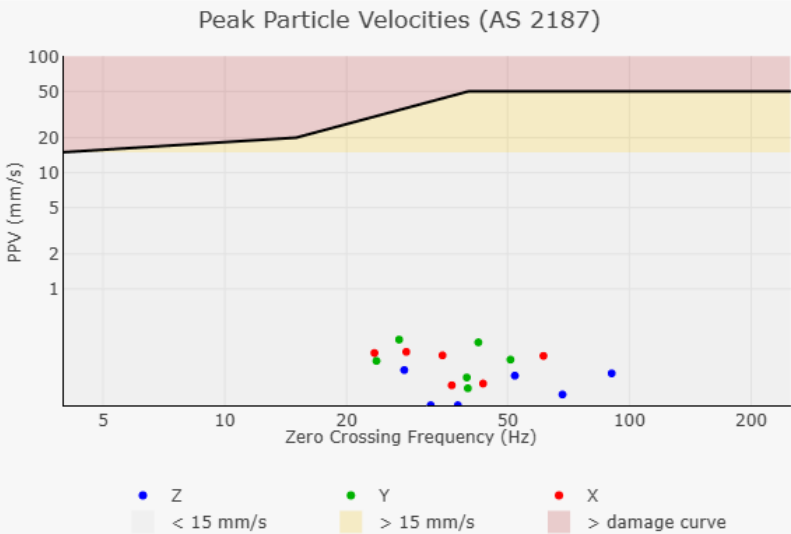
Per-component Peak Particle Velocities (PPV) vs. Zero Crossing Frequencies.  
Line indicates cosmetic damage guidelines  
(residential buildings, Fig. J4.4.2.1, AS 2187.2:2006).
