Ground Vibration Report

| Event Time | 18:35:18 Australia/Melbourne |
| Location | Phoenix 3715 LPH 5750 |

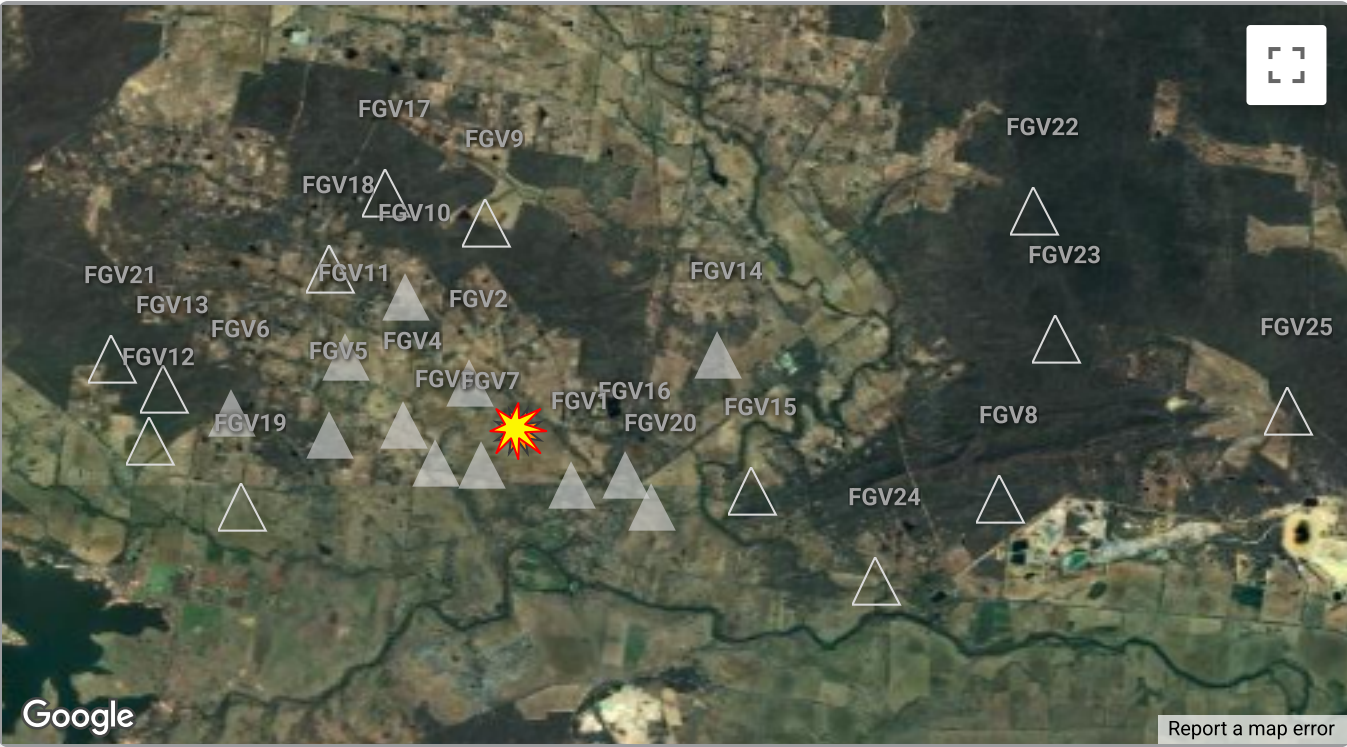
| Distance Below Surface | ~1420 m |

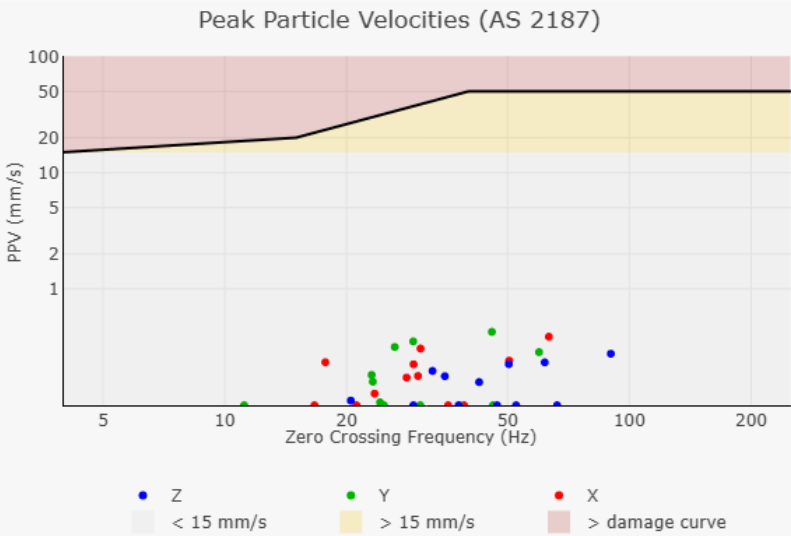
Per-component Peak Particle Velocities (PPV) vs. Zero Crossing Frequencies.  
Line indicates cosmetic damage guidelines  
(residential buildings, Fig. J4.4.2.1, AS 2187.2:2006).
