Ground Vibration Report

| Location | Phoenix 3840 LPH 6085 |

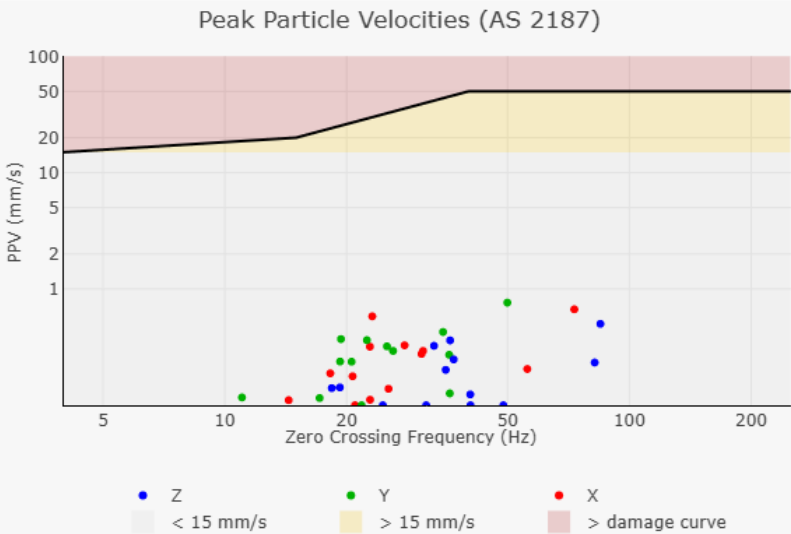
Per-component Peak Particle Velocities (PPV) vs. Zero Crossing Frequencies.  
Line indicates cosmetic damage guidelines  
(residential buildings, Fig. J4.4.2.1, AS 2187.2:2006).
